ROSS ENVIRONMENTAL ASSOCIATES, INC.

RE: *Follow up Indoor Air Screening*
Clegg Residence – Wolcott, Vermont (SMS# 2008-3857)

Indoor Air Screening

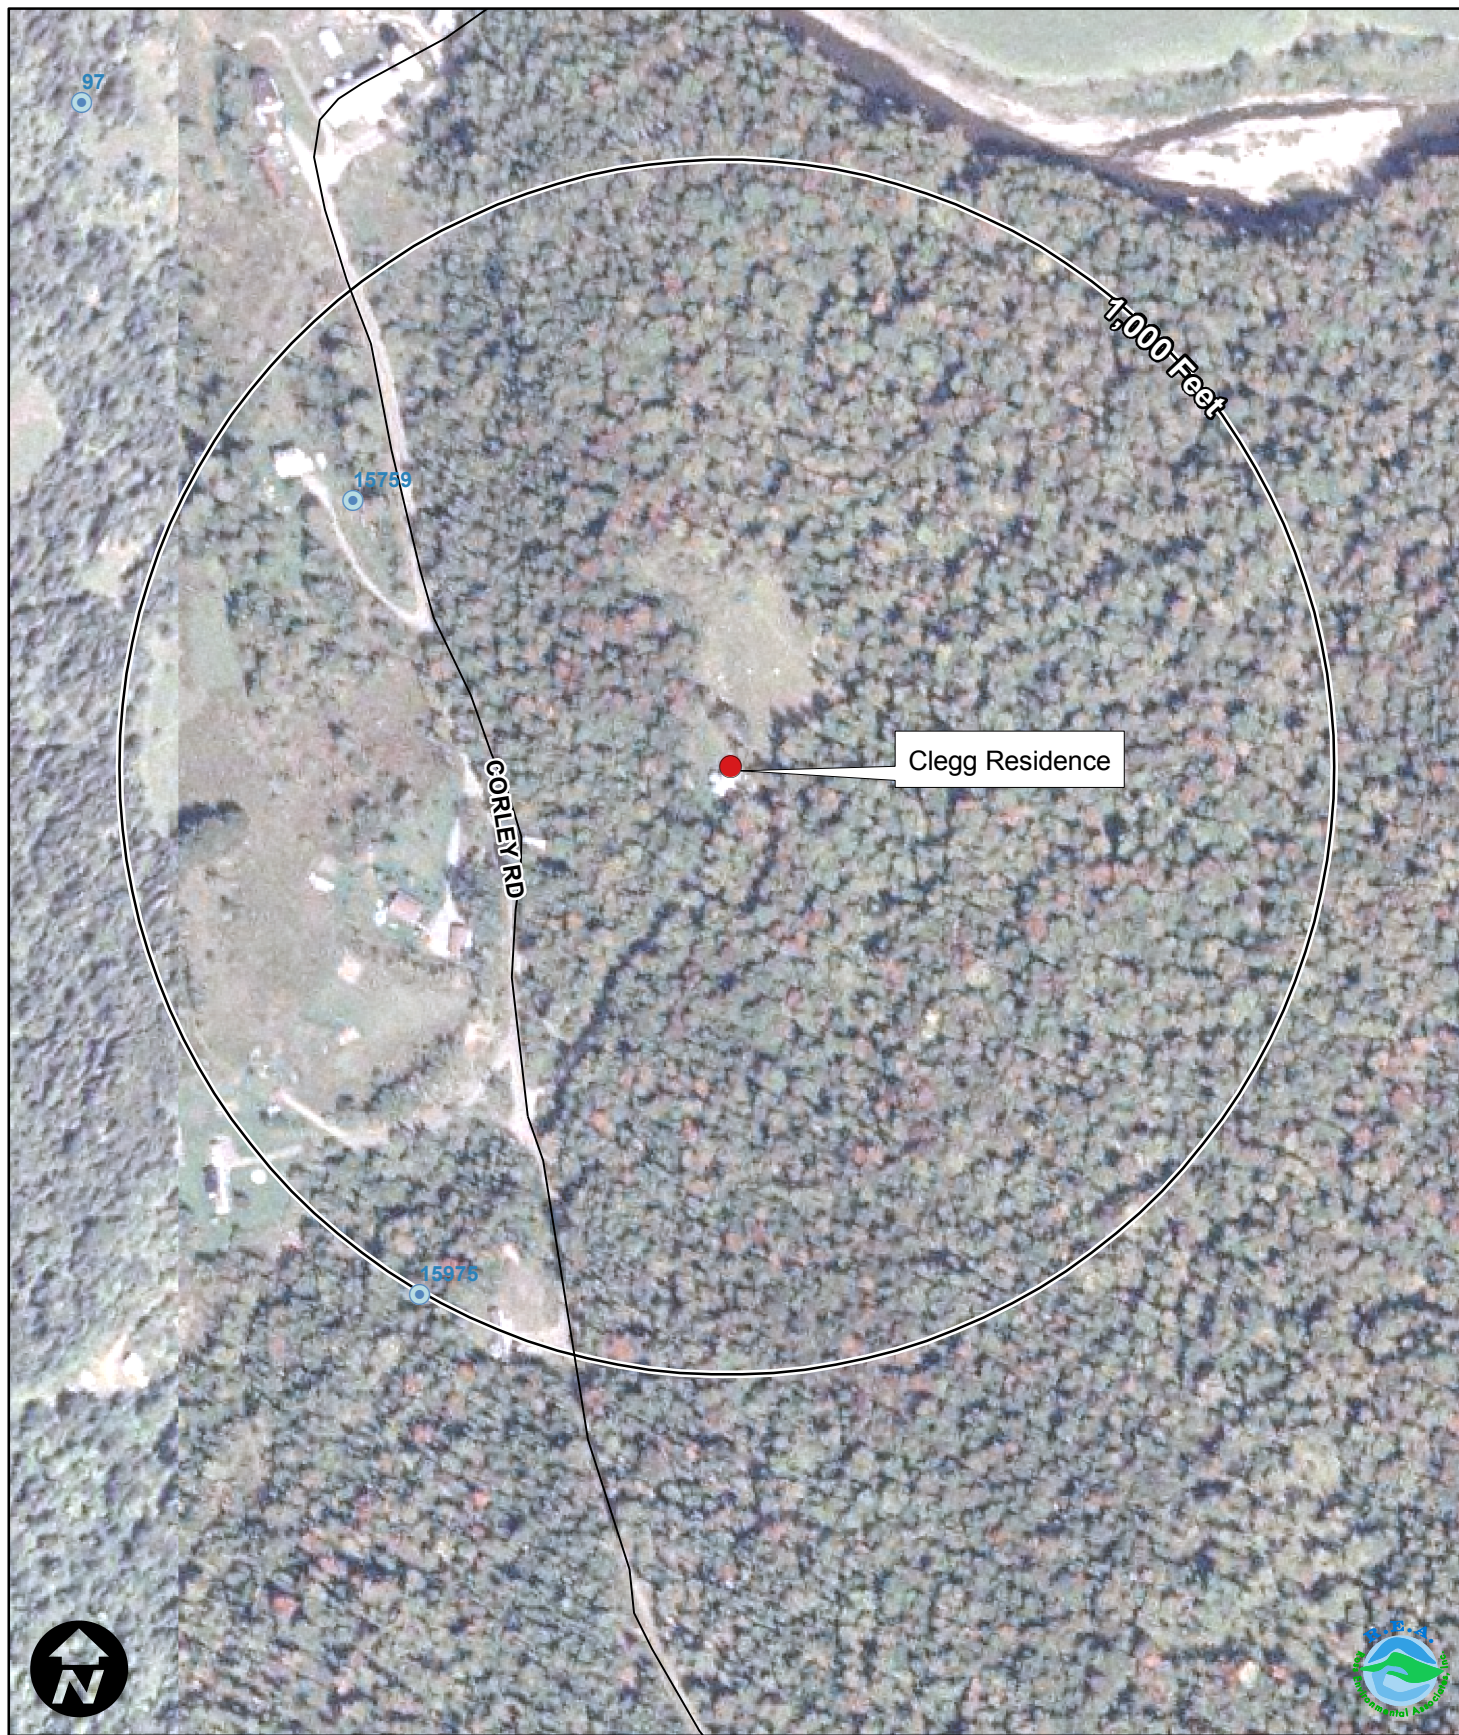
- PID readings of the expansion joint crack on the eastern side of the basement were all 0.0 ppm.
- PID readings ranging from 0.0 to 18.7 ppm were encountered at the north foundation wall/floor interface.

- PID readings ranging from 19.1 to 28.5 ppm were encountered in a small visible gap at the south foundation wall/floor interface at the southern end of the western expansion joint crack.

L-18	0.0	floor wall seam at north foundation wall
L-19	0.2	floor wall seam at north foundation wall
L-20	1.9	floor wall seam at north foundation wall
L-21	3.7	floor wall seam at north foundation wall
L-22	18.7	floor wall seam at north foundation wall
L-23	0.7	floor wall seam at north foundation wall
L-24	1.9	floor wall seam at west foundation wall
L-25	1.5	floor wall seam at west foundation wall
L-26	0.1	square hole for former support pole
L-27	0.0	floor wall seam at south foundation wall
L-28	8.7	floor wall seam at south foundation wall
AVERAGE	4.9

However, low concentrations of residual petroleum vapors appear to be diffusing into the basement of the residence by way of preferential pathways not previously observed to be exhibiting elevated PID readings during previous site visits. Observations indicate that the sealing of the main pathways and the seasonal operation of the radiantly heated floor appear to have contributed to the elevated PID readings in the identified areas. Historically, background ambient air PID readings within the basement of the residence have been below 1.0 ppm. No sampling or laboratory analysis of indoor air has been completed at the site. *R.E.A.* recommends completing an evaluation of mitigation options, including but not limited to: resealing of the entire basement floor and/or the installation of a sub-slab depressurization system. The mitigation evaluation may also include an assessment of facilitating an indoor air sampling program at the site.
